# Evidence-Based Research on Barriers and Physical Limitations in Hospital Public Zones Regarding the Universal Design Approach

The researcher is contributing to the project named “Evidence-Based Research on Barriers and Physical Limitations in Public Zones Regarding the Universal Design Approach: The Case of Naresuan University (NU) Hospital”, which consists of a process of empirical study on structural features and environmental design, mainly focusing on the level of accessibility of people with disabilities regarding the service functions and facilities within the public zone of the hospital.

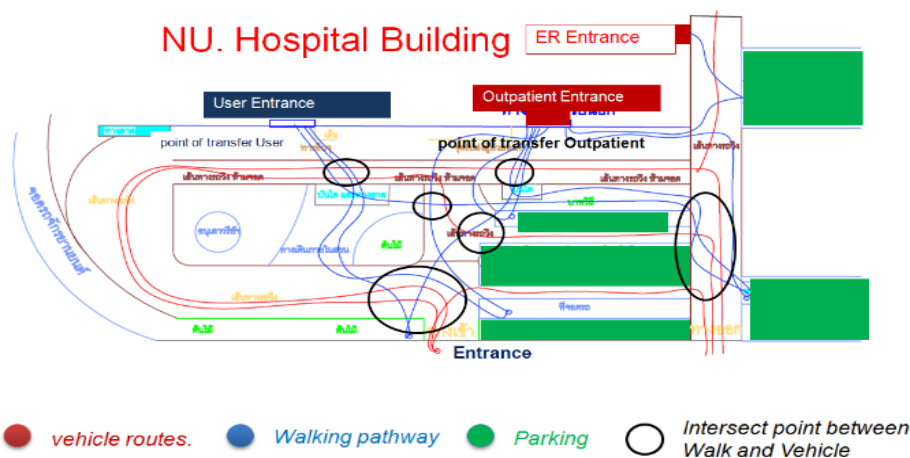
4.1.1 The exploration map illustrates the walking and vehicle routes approaching the entrance to the hospital building.

Figure 1. The exploration map of the vehicle ways and walkways according to the actual situation of NU Hospital

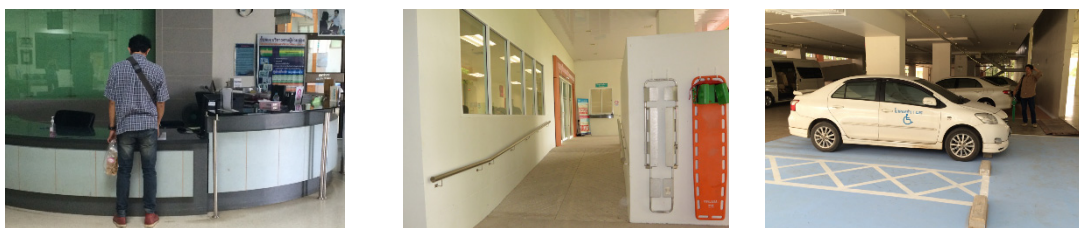
4.1.3 Exploration of various facilities, specifically for people with disabilities, with paying attention to signage, ramps, elevators, and furnitures such as waiting-room chairs, counters, and etcetera.

Figure 3. Images of facilities at NU Hospital - a service counter, an indoor ramp, and a parking space for disabled people

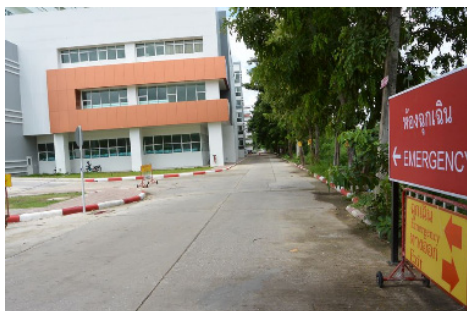
Figure 4. Current condition

#### 4.2.11 Hospital Approach: Approaching the hospital towards the inner hospital area.

*Example;* The vehicle route that approaches the emergency room (ER) from outside the hospital should have an obvious sign to promote the location of department. High-intensity color painted on the road, plus the addition of a large-size

nameplate, would help to make the ER more accessible and visible. Even saving a few seconds for someone in an emergency situation could save a life, and increased accessibility and visibility may help vehicles get to the ER door a little faster.

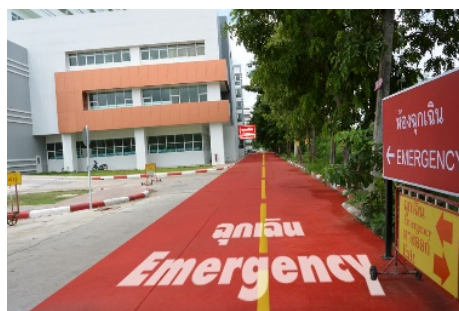
Figure 5. Simulation feature  
(Bunyasakseri & Phaholthep, 2014)

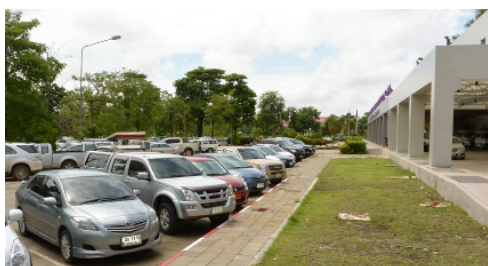
Figure 6. Current condition

- The signage showing where to park is not clear.
- There is no sign or signal leading in the parking lot for people with disabilities to guide them to disable parking spaces.
- There is no footpath or an obvious non-vehicle passageway, making it dangerous for people as they have to share the passageway with vehicles.

4.2.12 Car parking area in front of the hospital entrance

*Example;* of the new improved parking lot, with consideration for people with disabilities, and the elderly. Handicapped parking spaces should be located at the nearest parking lot area to the main entrance of the hospital, and each handicapped parking space should provide extra room for wheelchair users, including room enough for them to get in and out of their vehicles (blue label in the picture). In addition, there should be an appropriately-wide ramp to the building entrance, plus safety rails. The material surface should be painted with a vivid color to accommodate the visually impaired.

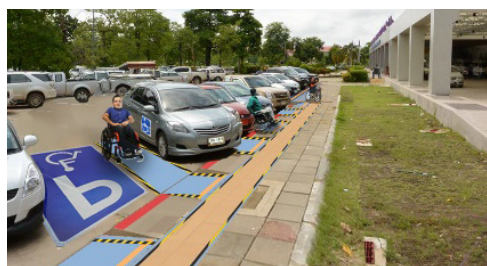
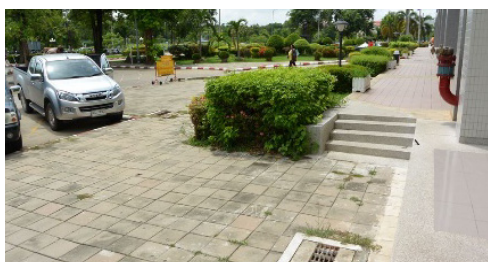
Figure 7. Simulation feature (Bunyasakseri & Phaholthep, 2014)

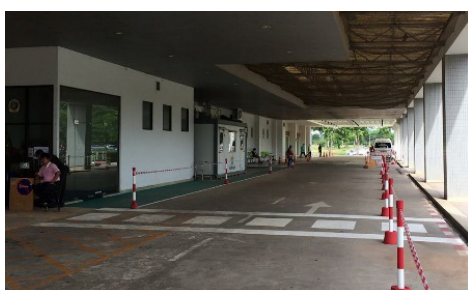
Figure 8. Current condition

- Temporary drop-off at the building entrances has no signage (or signage that is not clear enough)
- The distance between the drop-off point – where people get out of the vehicle - and flowing vehicle traffic, is very slight, which can cause serious harm if someone to someone getting out of a vehicle.

4.2.13 Passage to the building.

*Example;* The illustration shows improvement of space in front of the hospital entrance. This area is also used as a drop-off point. For safety reasons, the design suggestion is to install a safety rail to provide separation between pedestrians and vehicles, and to add a speed bump on the traffic surface. As well, all of the new equipment should be vividly painted with warning colors. In addition, the nameplate and banner of the main entrance could be improved by enlarging its size and adjusting its position, making it easy to be seen from a distance.

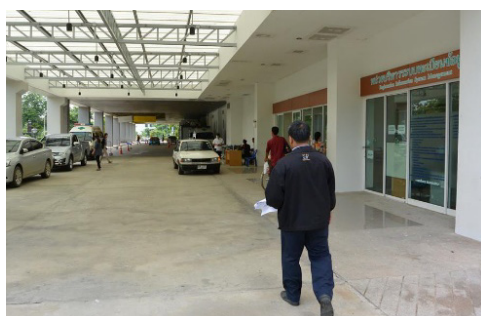
Figure 10. Current condition

- The pathway around the building entrances, and the Outpatient Department (OPD) main entrance, has no cues (such as tactile paving) to help navigate the visually handicapped, and there are objects, such as chairs, that obstruct the passageways. There are other obstructions as well in the general building-entrance area. Especially for the visually impaired, there is a lack of cues to guide people to where they need to go.

*Example;* These illustrations present a guideline to improving the OPD entrance. Firstly, the footpath should be clearly separated from the road and painted with any vivid color. Secondly, the OPD entrance sign should be enlarged and clearly readable from both the footpath and the road. Thirdly, the cars are colored red in the simulation picture to signify that they should be removed (Figure 11). Allowing vehicles to park in this area may cause congestion and even chaos. Parking here should be forbidden because of a high number of people and vehicles at peak periods.

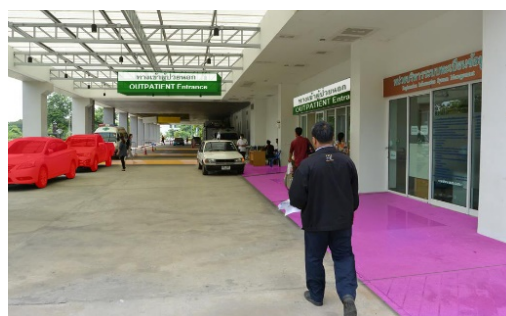
Figure 11. Guideline feature simulation (Bunyasakseri & Phaholthep, 2014)

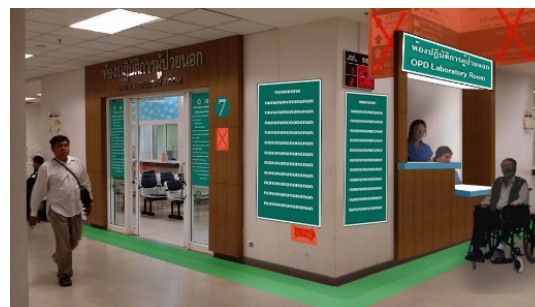
Figure 13. Guideline feature simulation of the intersection in front of the entrance to the blood test lab (Bunyasakseri & Phaholthep, 2014)

*Example;* The blood test lab would be improved by introducing a new service counter facing the main corridor for easy access and visibility, and improved service. The counter itself should have two levels to accommodate more types of physical conditions. The instruction board should be enlarged and reinstalled next to the counter. This would make it much easier for people to notice, and to read. The signage at the middle of the intersection should be reordered.

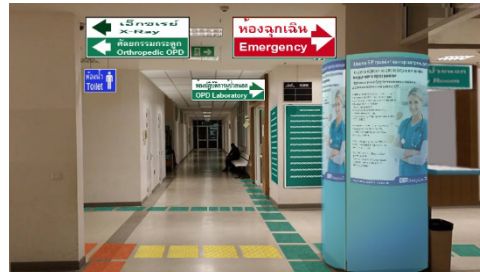
Figure 15. Guideline feature simulation of the corridor intersection in front of the blood test lab (Bunyasakseri & Phaholthep, 2014)

*Example;* The illustration demonstrates that the signage at the corridor intersection, which is supposed to guide people to various service points, should not be put exactly at the middle of the intersection, and should not contain too much information. These misapplications cause blockage on the corridor from people who are constantly stopping at this point to attempt to gather information about where to go next. The signage should be located before the intersection, its font should

be more readable - with sufficient contrast between the lettering and the background - and there should be less with succinct information on the signage. More information could appear later on further signage, after the users have moved along to the next navigation point. These changes would surely result in less crowding and less confusion. Beyond that, to further increase the level of performance by the wayfinding system, color classification may be used to improve visibility and recognition. The signs, banners, nameplates and lobby/facade of each important department could be classified by color all over the hospital, such as an emergency department could be painted red, the specialist departments green, blue signs could signify lavatories, and on and on. An information board could be installed on the building columns support poles around this area, not only for providing information but to serve as a recognizable visibility landmark, from both close up and from far away. Regarding the matter of floor materials, colored tactile paving (Braille blocks) could be applied systematically along the corridors to help the visually impaired or the blind with navigation. These specific-color floor tiles would improve the wayfinding system for general usage as well.

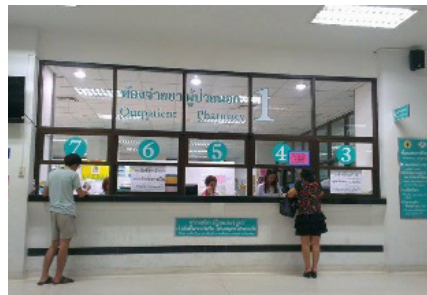
- Most of the participants are unable to find the OPD pharmacy because there is no clear sign or nameplate to present the location of this facility.

- This facility is located along a main passageway, where a lot of people pass through for various purposes. During the peak period, the queue goes across the passageway, creating inconvenience and obstruction for both those in queue and those passing through on the passageway. This situation frequently causes the blind and wheelchair bound to be overtaken in queues, and in general makes it difficult for them to reach the pharmacy counter.

- The pharmacy counters used for submitting payment and receiving medications are too high for wheelchair-bound persons. It is inconvenient for them when trying to communicate with the pharmacist so as to receive their medication.

Figure 16. The current condition of the pharmacy located along the main passage

*Example;* The pictures demonstrate how the simulation features can improve the use of space at the pharmacy, especially for making the area more accessible and convenient for people with disabilities. Simulation features include tactile paving along the walkway to the pharmacy counter to help the blind and visually impaired find their way, and more vivid colors at the pharmacy counter and/or a redesign of the department nameplate or banner to facilitate recognition and navigation as well. Moreover, a lower counter for use by persons with certain disabilities, or the elderly, could be introduced, possibly set off to the side in order to prevent congestion.

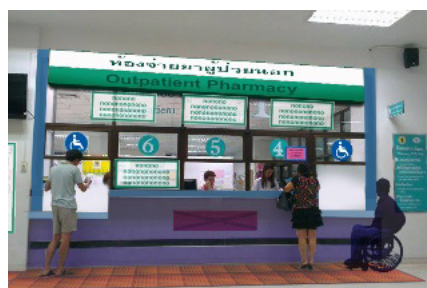
Figure 17. Guideline feature simulation of the pharmacy (Bunyasakseri & Phaholthep, 2014)

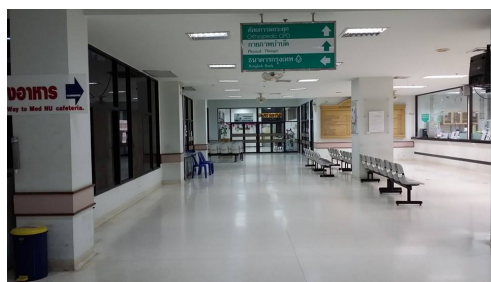
- There is no tactile paving (Braille blocks) nor audio signaling to help the visually impaired and the blind navigate, and to help them be aware of their environment.

- There is often a high density of patients congested in front of the department entrance, waiting for their treatment. Thus, the visually impaired and the blind find it difficult to get to the registration counter because the entrance is impeded.

Figure 18. The current condition of the corridor intersection in front of the entrance to the Orthopedic Surgery department

*Example;* The improvement guideline illustration is a simulation of the actual corridor intersection and walkway leading to the entrance to the Orthopedic Surgery department. The signs have been installed in a location that is easily seen from the pathway. The pathway is coming from the elevator hall, so the location of the nameplates should be before or after the intersection. In addition, the signs of each department should use different colors for easy access and recognition, the details about that having been mentioned earlier. Moreover, each department should be vividly decorated to create a noticeable atmosphere, easy to notice and to see even from a distance. Each department and service facility could be marked by different colors, and color coordinated with the signage and guiding floor tiles. This will definitely improve user wayfinding, and provide an overall atmosphere improvement within the hospital. Please keep in mind that there should not be too much information posted, or too many signs and other markers scattered about, as this can cause confusion, and ultimately cause signage and navigation system failure. Moreover, not only the application of specific floor tile materials to increase navigation for all physical abilities is important, but the location and positioning of furniture should also be carefully considered, and set up at the appropriate places. There should be no obstructions to pathways, for example, especially to the blind and visually impaired. Non-public entrances and non-public areas should be very clearly marked to prevent confusion and unwanted visitors.

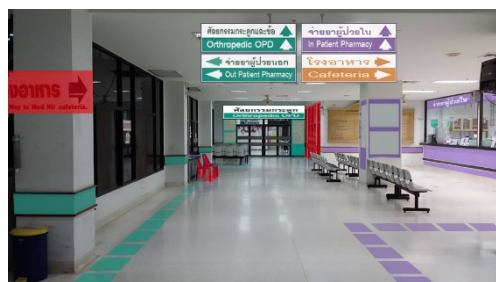
Figure 19. Guideline feature simulation of the corridor intersection in front of the entrance to the Orthopedic Surgery department (Bunyasakseri & Phaholthep, 2014)

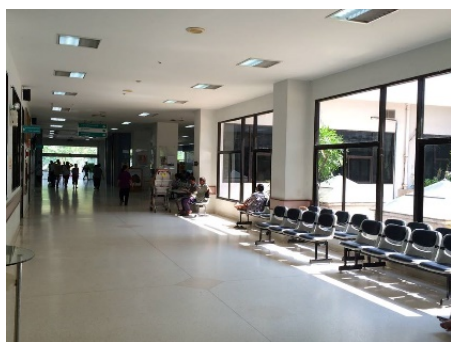
- Wheelchair-bound persons require more effort to find the cashier because the section nameplate is not installed at the appropriate location for them to see it clearly.

- There are no cues to navigate the blind to the OPD cashier, thus blind persons cannot find this section themselves. (In the simulation exercise, staff have to lead them to the OPD cashier.)

- The height of the payment window is too high for wheelchair-bound persons, causing communication difficulty for participant and cashier staff.

- During the peak period, so many people stand in queue to access this service that the queue goes across the main corridor, where many people are passing through. There is such chaos and confusion sometimes that at times people with disabilities are overtaken in the queue.

Figure 20. The current condition of the main corridor and the cashier counter

*Example;* The design guideline simulates the feature of navigated Braille blocks which are installed at the rim of both sides of the pathway to avoid the pedestrian traffic flow in the middle. As the Braille blocks are applied in two colors - green and orange – they not only benefit the blind and visually-impaired, but also help other users in finding their destinations; the orange blocks guide users towards all points from the inner building to the cashier counter, while the blue blocks serves as a navigation tool for users who are going to any point from the building entrance to specific departments inside the hospital building.

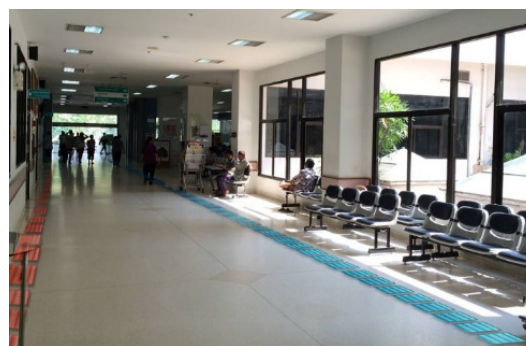
Figure 21. Guideline feature simulation of the main corridor and the cashier counter (Bunyasakseri & Phaholthep, 2014)

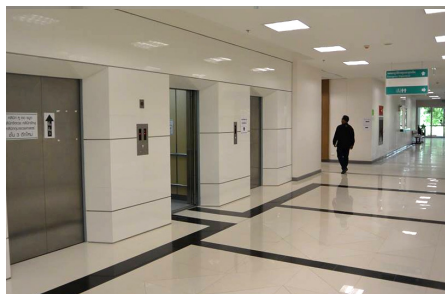
Figure 22. Current condition of the Elevator Hall and Corridor of NU Hospital's new building

*Example;* The elevator hall is located along the main corridor. At that location users who have just exited from the elevator regularly have to make a decision about where to go next. As the current design of the elevator hall is quite monotonic, and because the elevators are located in a busy flowing area – especially at peak times – along the main corridor, and in fact contribute to that since people are constantly entering and exiting the elevators, there is often chaos and congestion in the elevator area. The suggestion to reduce the problem from the said causes is to make the elevator area boldly stand out

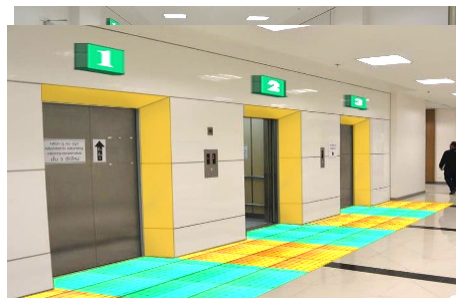
Figure 23. Guideline feature simulation of the Elevator Hall and Corridor of NU Hospital's new building (Bunyasakseri & Phaholthep, 2014)
